## **Bridge works progressing well at Laverton and Gretton**

### Laverton Bridge Replacement

### **Gretton Bridge (Bridge 26) 'bash' repairs**

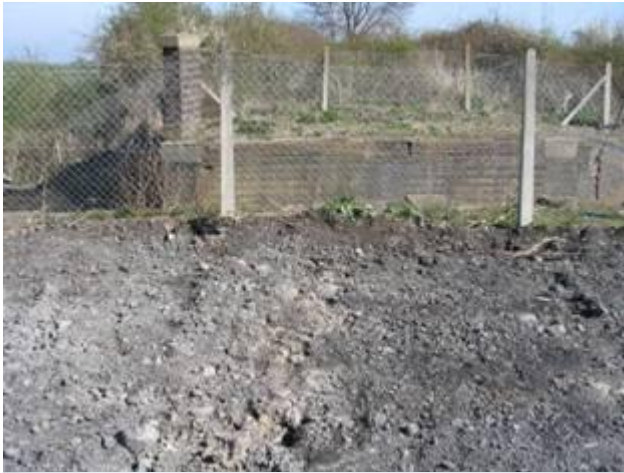
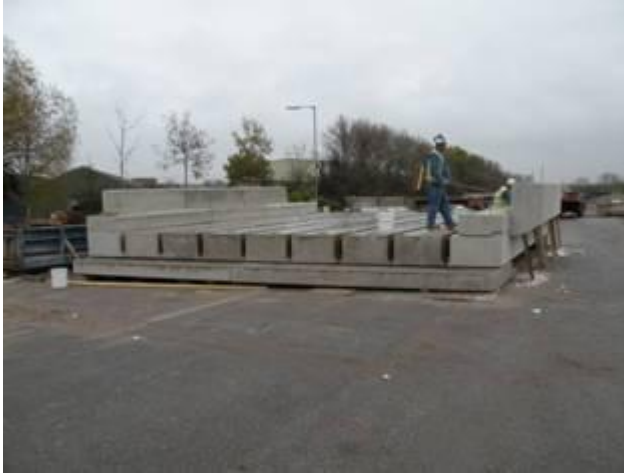
Above: Looking towards Broadway from the track bed and the deck of the new bridge

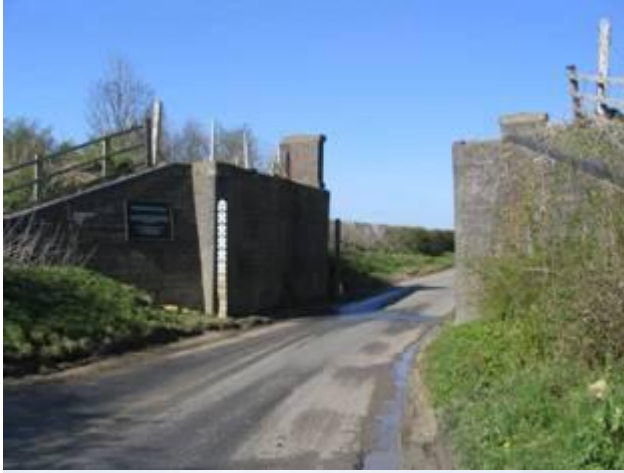
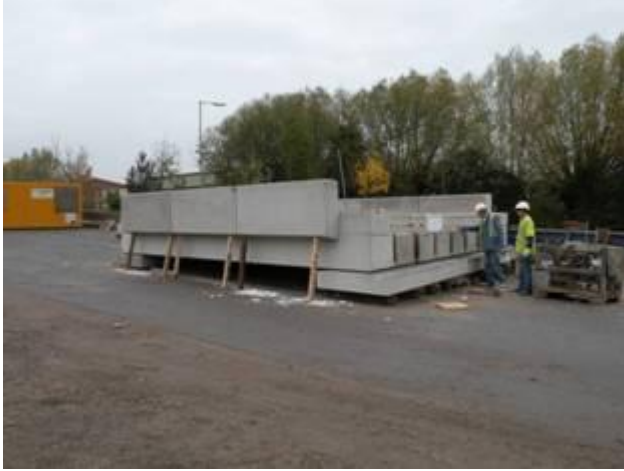
Above: The east side of the 'Laverton Gap' will have the brick pilasters replaced (you can see those on the opposite side) when the bridge is reinstated. The deck beams (below) will be grouted together to form an one integral unit

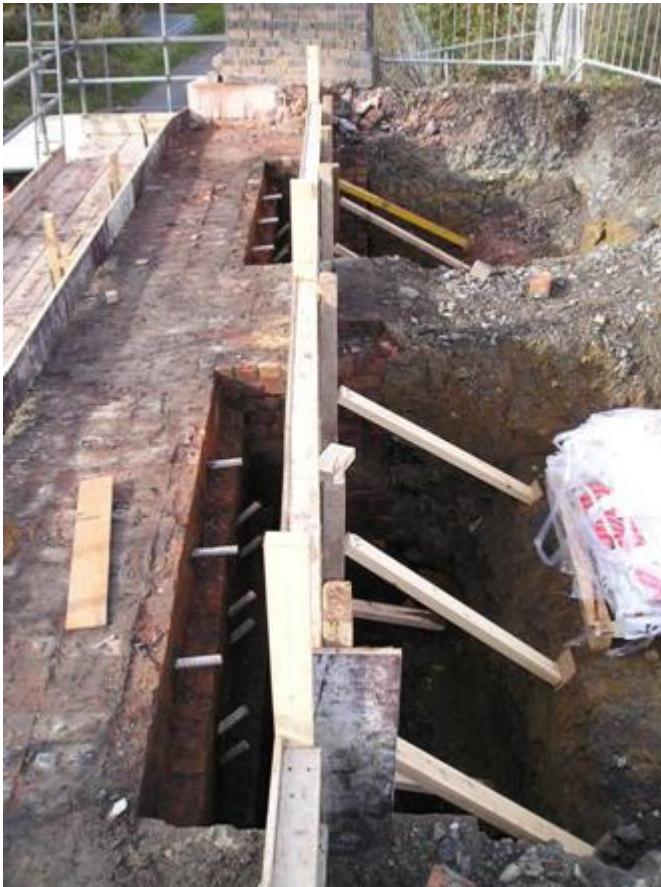
Above: Dowels drilled into the abutments and the area behind will be tied in and filled with concrete so the cill beams will be able to provide sufficient support for the much heavier structure than the original bridge

The brick bridge abutments have been reduced in height to take new pre-cast concrete cill beams and the redundant brickwork has been taken to Broadway by Alan Beilby (around 120 Bricks). Whilst this may not sound a great deal, these are genuine Great Western bricks and will be useful in the Broadway station reconstruction work.

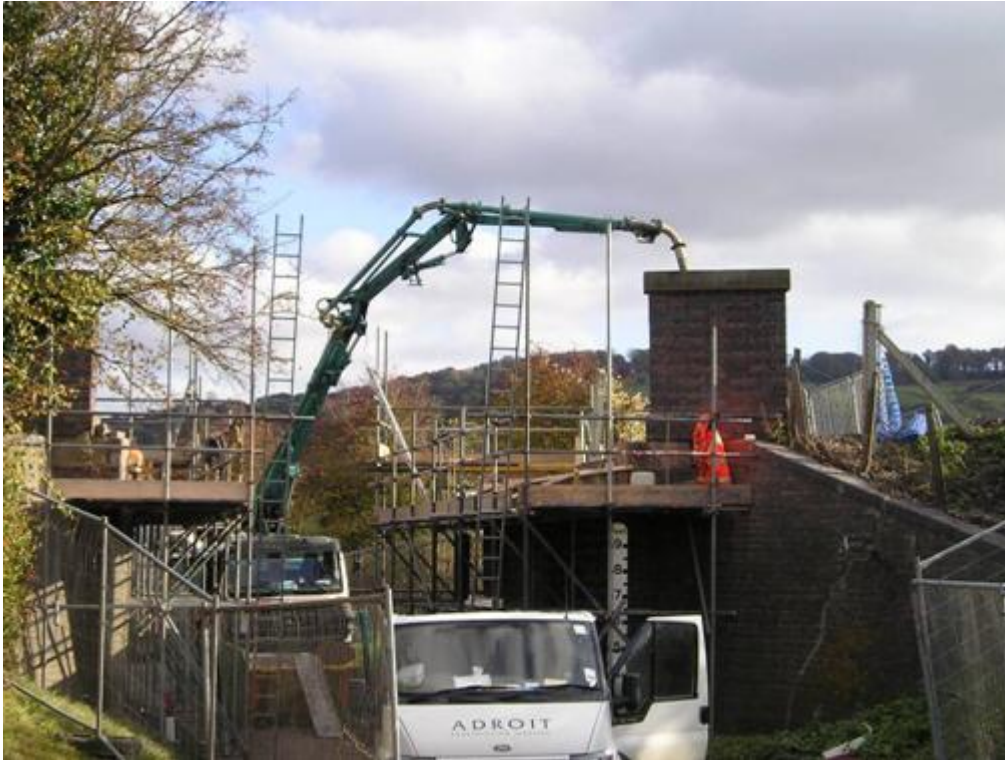
Above: A concrete pump being used to pour concrete for the abutment strengthening work to the Toddington side of the bridge.

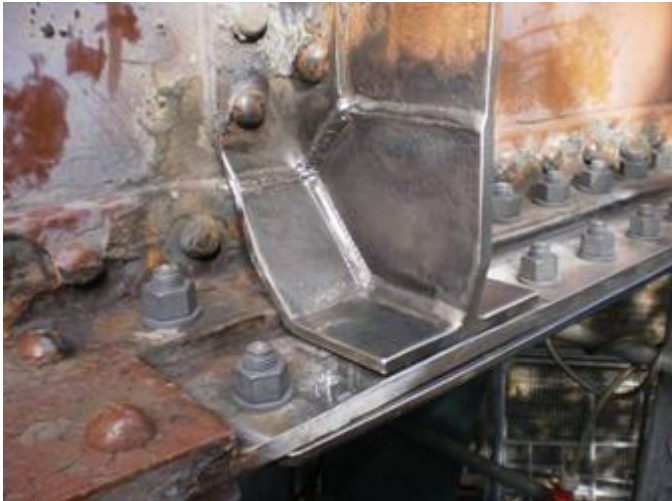
The bridge bash repairs were successful and involved the heavily damaged and bent section of the Cotswold side support beam being cut out and a new section welded in. This work was done when trains were not running and the weight of the bridge was taken up by heavy supports – which is why it was necessary to close the road.

Above: Picture by John Balderstone shows of the repair before the stiffener and bottom plate were drilled and bolted up.

However, we are delighted to report (on 1<sup>st</sup> November – three weeks early!) that all work, including additional work authorised to take advantage of the road closure and the presence of the scaffolding. This included blast cleaning (with environmental protection) and painting the corroded underside of the structure and inspection of the difficult-to-get-to areas; and repairs to one pilaster.
